Operation TEAPOT

Project 3.1

RESPONSE of DRAG TYPE EQUIPMENT
TARGETS in the PRECURSOR ZONE (U)

Issuance Date: October 28, 1959

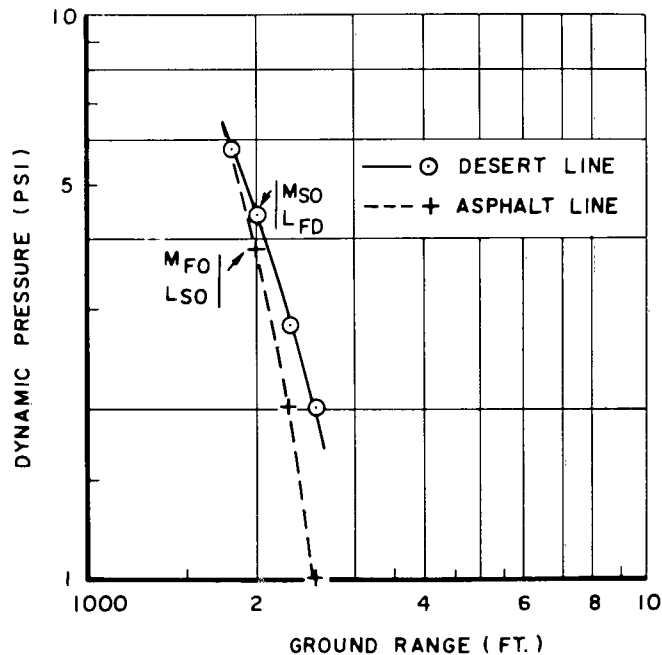
Fig. 4.1 Plot of Damage to 1/4-Ton Trucks on a Dynamic Pressure-Distance Curve, Shot 6

Shown in Figures 4.1 and 4.2 are plots of the damage sustained by vehicles on a dynamic pressure versus distance curve for Shots 6 and 12. Where the degree of damage differed for orientation, (face-on and side-on) at each location it is so noted on the curves by use of subscripts SO and FO. Two surfaces, desert and asphalt, provided a comparison of damage on Shot 6 while on Shot 12, three surfaces, desert, asphalt and water, provided a comparison of damage. On both surfaces of Shot 6 damage to the jeeps was about the same. However, the jeeps were not located well within the precursor zone and no comparison over the total range of damage was obtained. On Shot 12, the degree of damage was not too greatly different over the three surfaces. Examina-

tion of the curves indicates a dynamic pressure of about 9 psi is required to cause severe damage to jeeps. Also, on the desert line at the 3000 foot station, the moderate damage to the side-on vehicle along with the large displacement noted implies that this value of dynamic pressure possibly is too low.

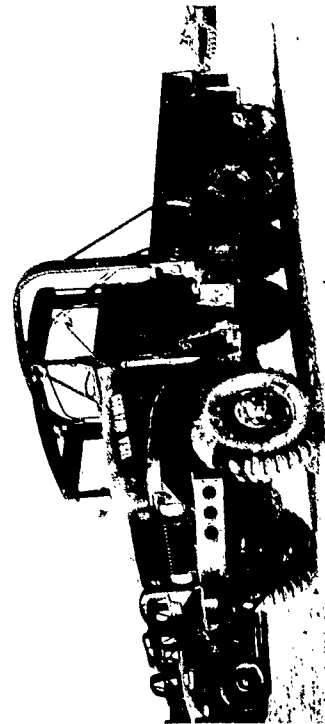
Fig. D.2 - Truck 1 Ton, with Roll-over safety Bar. M58A1 Vehicle after Tests

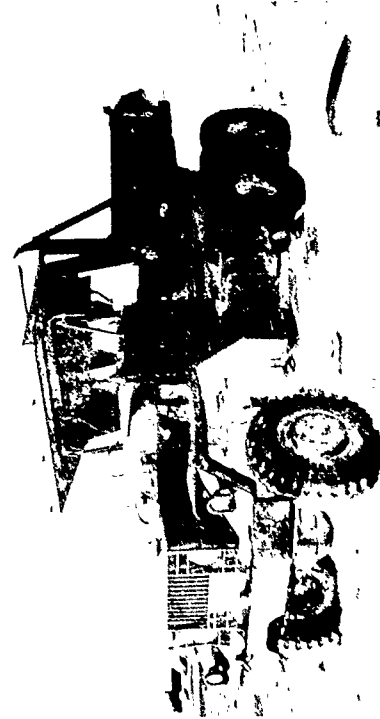
Fig. D.7 - Damage to 5-ton Dump Truck, M1, 917 ft from Ground Zero, Shot 1

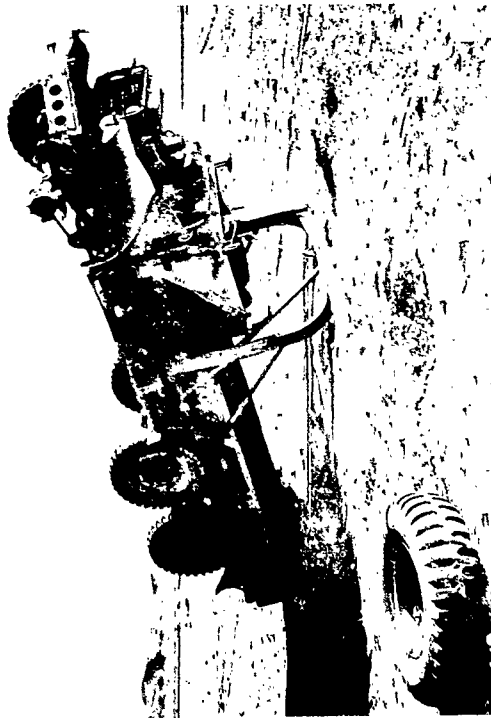
Fig. D.9 - Truck, 2 1/2 Ton, M135, 1200 ft from Ground Zero After
Shot 2. Protection was Afforded Cab by Roll-over
Safety Bar

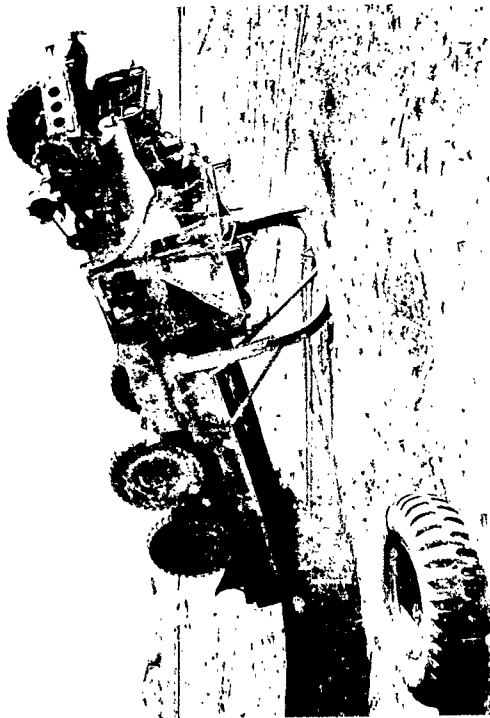
Fig. D.9 - Truck, $2\frac{1}{2}$ Ton, M145, 1400 ft from Ground Zero After Shot 2. Protection was Afforded Cab by Roll-over Safety Bar

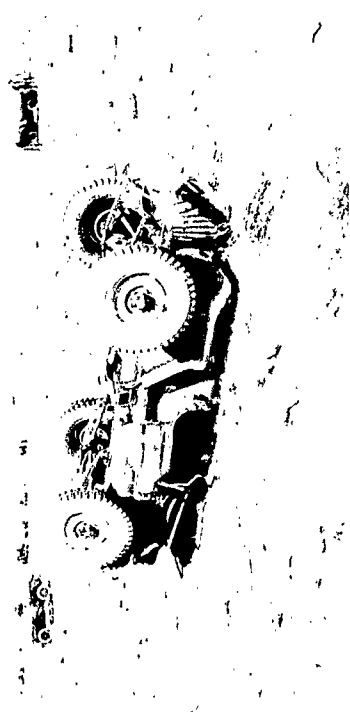
Fig. D.12-Jeep on Desert Surface, Shot 6,
Side-on, 1200 ft from Ground Zero.

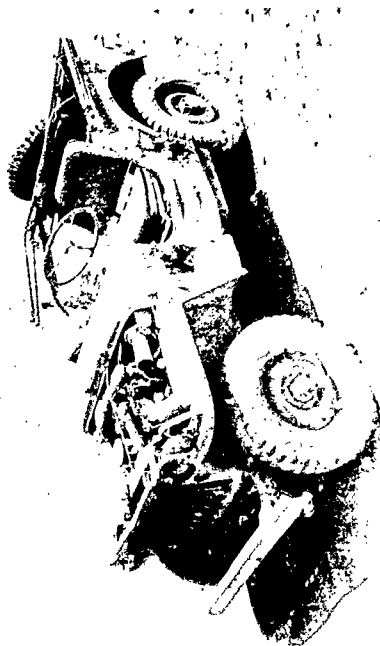
Fig. L.41 - Jeep, Side-on, 2000 ft from Ground Zero, Water line, After Shot 11. Jeep was blown over rear dike around water line.

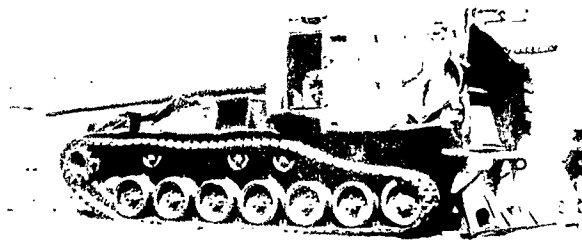
Fig. D.50 - T97, Face-on, Breaks Off, 2050 ft
From Ground Zero, After Shot 13.
